BUILDING-STRUCTURE INVENTORY FORM

1. BUILDING NAME(S): _____
2. COUNTY: Monroe TOWN/CITY: Greece VILLAGE: ---
3. STREET LOCATION: 320 Kirkwood Road
4. OWNERSHIP: a. public ☐ b. private ☒
5. PRESENT OWNER: Mr. & Mrs. Edward Ritzman ADDRESS: (same) Rochester, NY 14612
6. USE: Original: residence Present: residence
7. ACCESSIBILITY TO PUBLIC: Exterior visible from public road: Yes ☒ No ☐
Interior accessible: Explain private residence

Town of Greece Historic Sites Survey
Monroe County, New York
320 Kirkwood Road
page 3

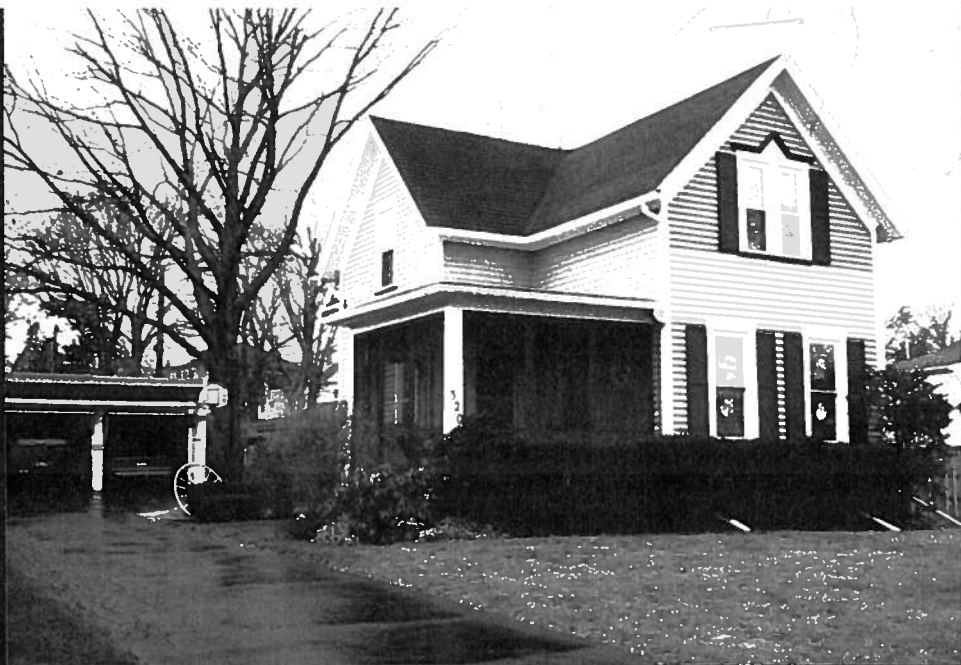
12. PHOTO:

"This looks like it has its original wood siding. There's not a lot of architectural detailing - it's mainly the paint color that gives it interest. I'd say a 'green plus' is appropriate." P.Malo.

18. This two-story residence is constructed in the familiar late 19th-century, cross-gabled plan. It is constructed of wood clapboards and has a fieldstone foundation. Original details include 1/1, double-hung windows. The front (east) gable features a pair of 1/1 windows topped by a decorative, pointed-arched wood molding. Contemporary louvered shutters flank the windows on the front (east) elevation.

The 1-story, front porch at the southeast corner of the house has original decorative turned posts. The porch is enclosed with wood-frame, screen panels. To the rear (west) of the house is a 1-story, shed-roofed section that appears to have been added at a later date (early 20th-century?).

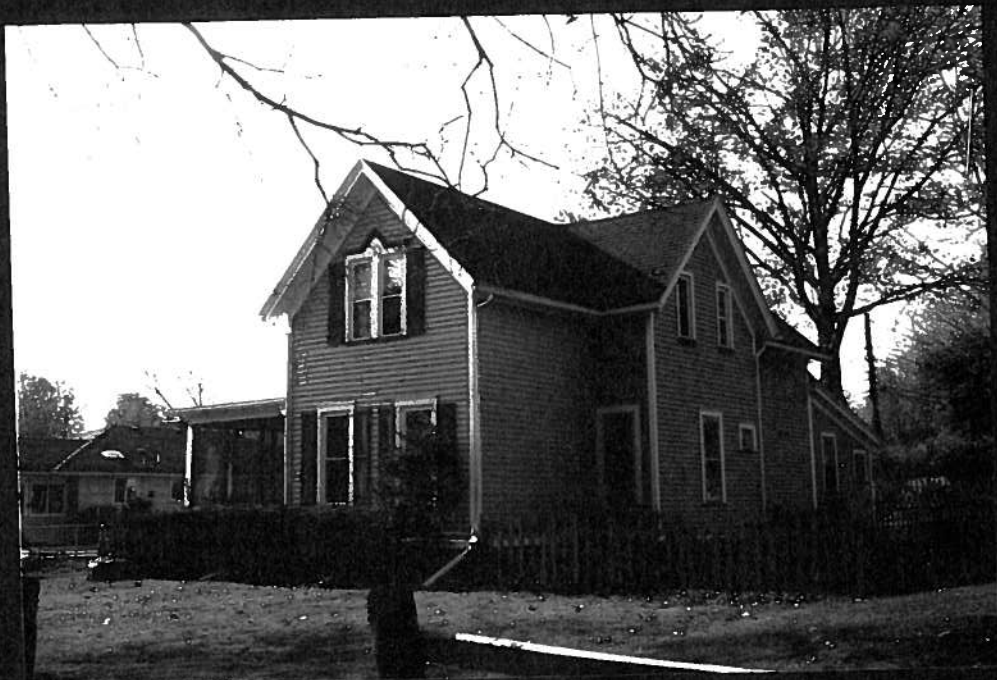
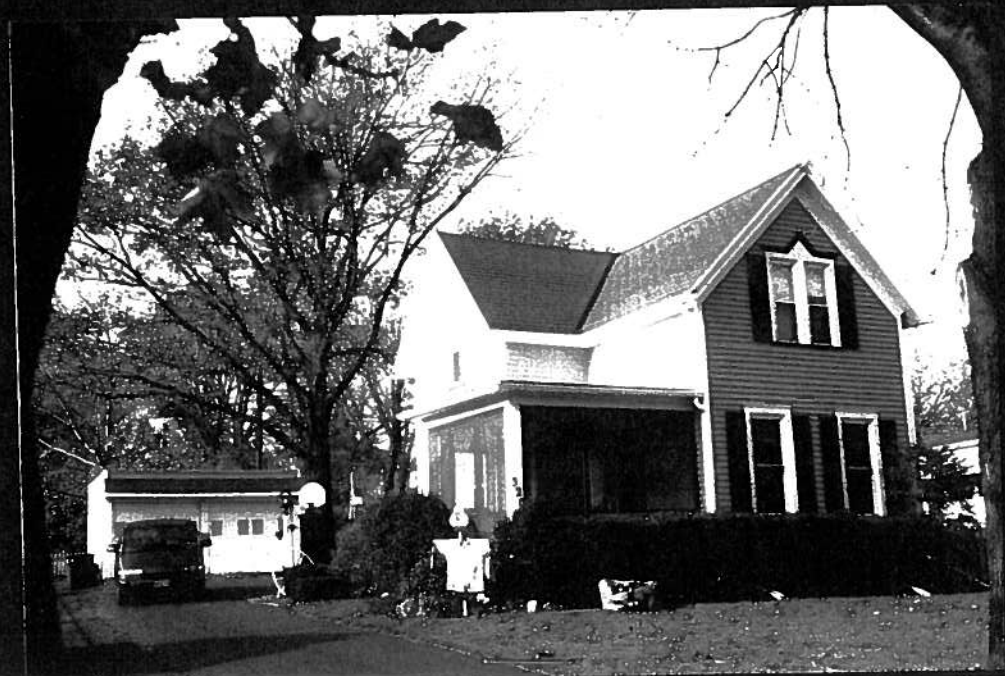
Rear (west) 1-story, shed-roofed addition (early 20th-century?) with clapboard siding.

The present louvered shutters on the front of the house are contemporary.

The porch has been enclosed with modern wire-screen panels.

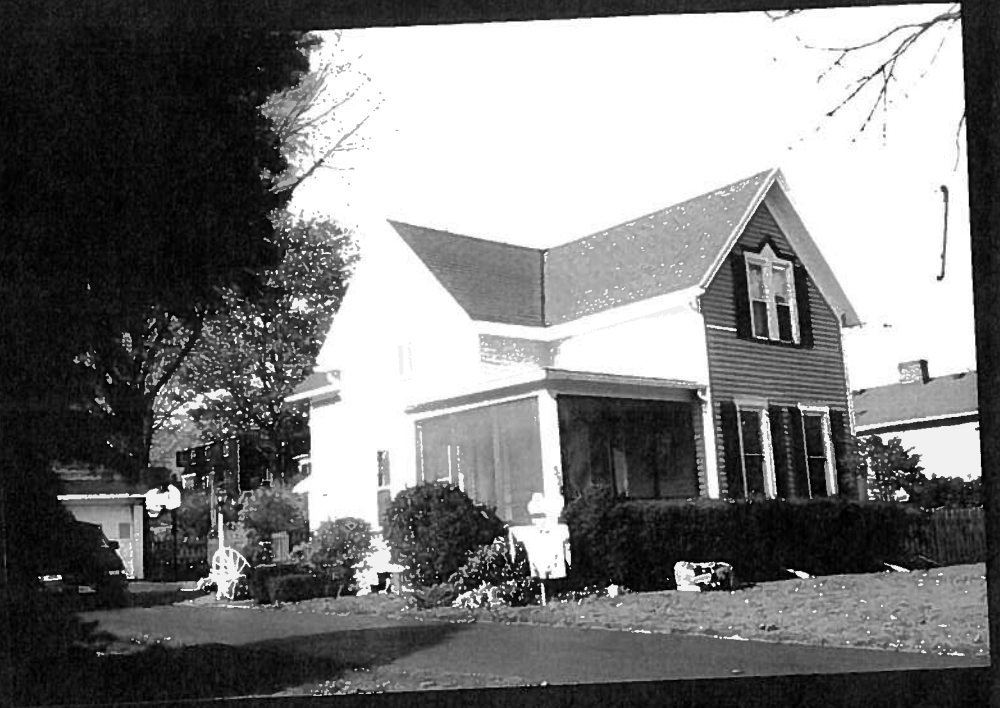
The two-car, frame garage with paneled overhead doors.
